# Fred Root & Associates

RE: Inspection at your new home

## SUMMARY

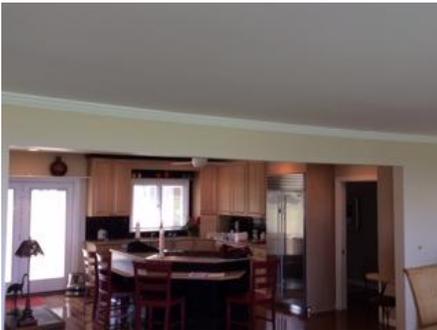
Location: Beam at the ceiling between the dining room and the kitchen

It appears that the structure in this location has been modified and there is noticeable deflection in the beam, and point load support for the roof structure may have been eliminated. I recommend further evaluation and certification by a qualified structural engineer.

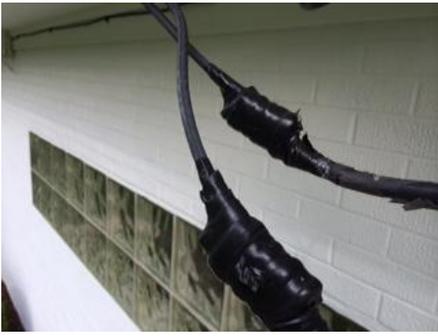
The electrical service panel and/or main breaker are rated for a 200 amp service, but based on the size of the overhead service cables; it would appear that the actual service to the house may be lower.

The height of the service entrance cables from the walkway does not meet current code requirements. Upgrading is recommended.

An upgrade to the service entrance cables is recommended to accommodate today's lifestyles.

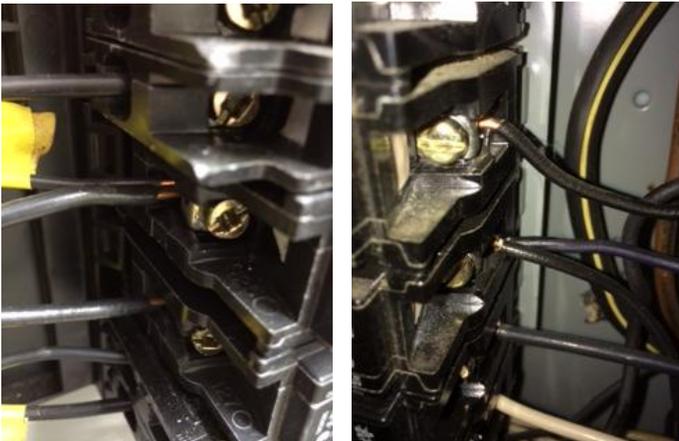
Location: All service panels

There are double taps and over fusing. I recommend further evaluation and repair as necessary by a qualified / licensed contractor.

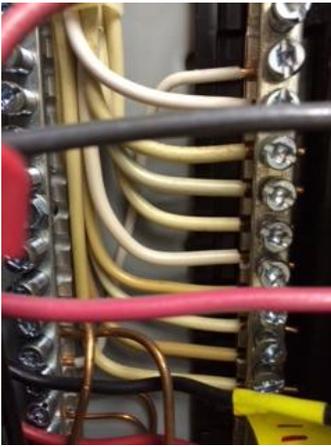
Location: Subpanel

The grounds and neutrals are bonded. I recommend further evaluation and repair as necessary by a qualified / licensed contractor.

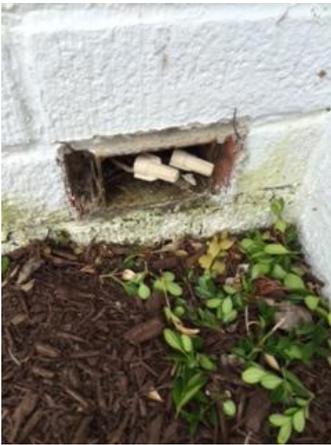
Location: NW inside corner of the house

There is an open junction box. This is a safety concern. I recommend further evaluation and repair as necessary by a qualified / licensed contractor.

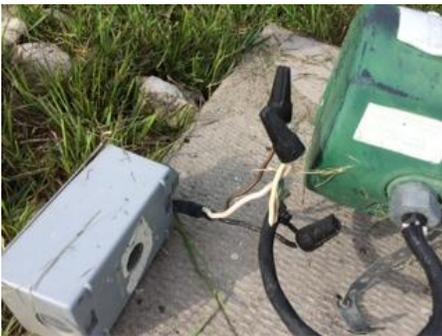
Location: Sprinkler system pump

There are exposed splices. This is a safety concern. I recommend further evaluation and repair as necessary by a qualified / licensed contractor.

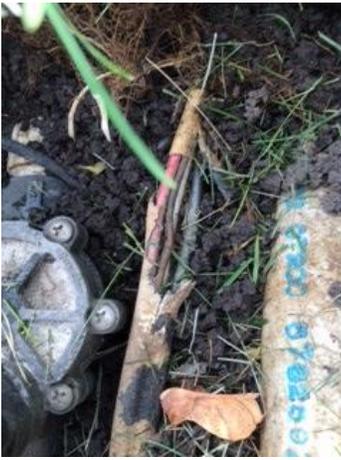
Location: Sprinkler system valve box near the street

The electrical cable insulation is damaged. This is a safety concern. I recommend further evaluation and repair as necessary by a qualified / licensed contractor.

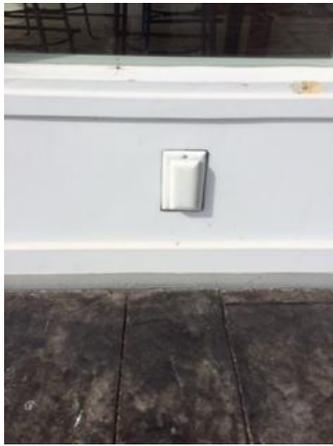
Location: East exterior wall of the sunroom, garage  
The GFCI outlets do not trip. I recommend further evaluation and repair as necessary by a qualified / licensed contractor.

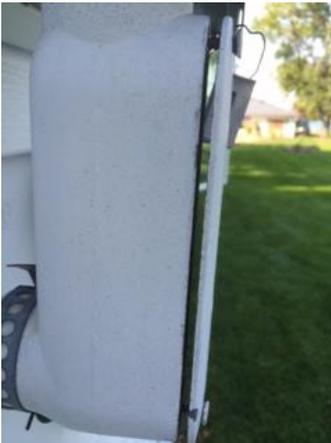
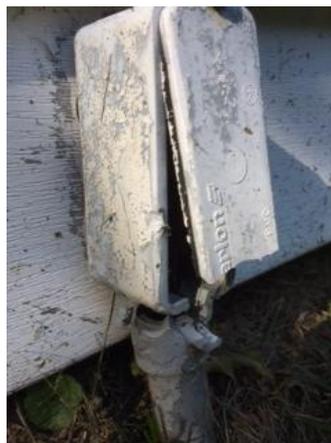
Location: East and south sides of the cottage  
There are damaged/open conduit elbows.

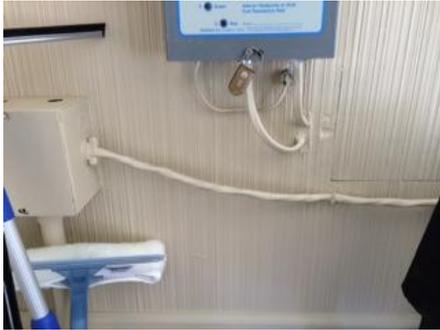
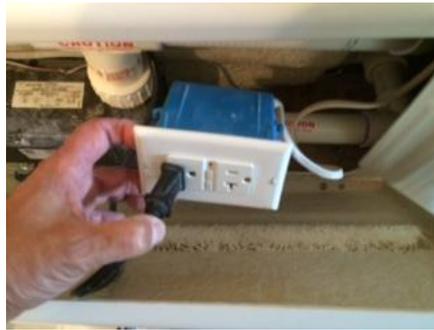
Locations include, but may not be limited to: Crawlspace, East attic space, hydro-massage tub enclosure and Garage

There are improperly routed/secured cables and/or open junction boxes.

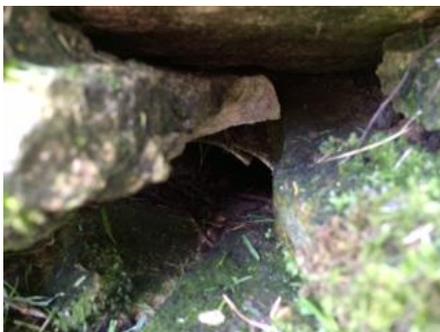
Location: NW

The extension appears to have been crushed and flow is restricted. I recommend further evaluation and repair as necessary by a qualified contractor.

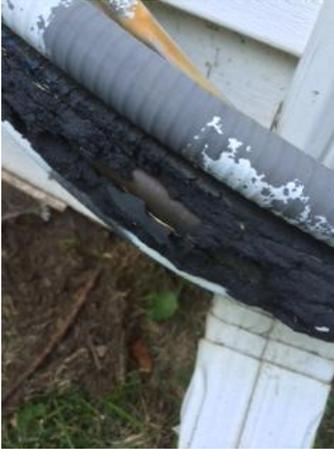
Location: Cottage

The coolant tubing insulation is damaged. I recommend further evaluation and repair as necessary by a qualified contractor.

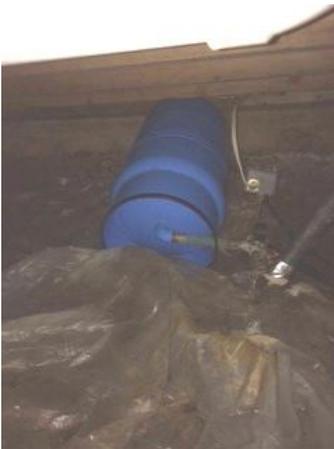
Location: Cottage crawlspace

The unit has been installed on its side and is not supported properly. I recommend further evaluation and repair as necessary by a qualified / licensed contractor.

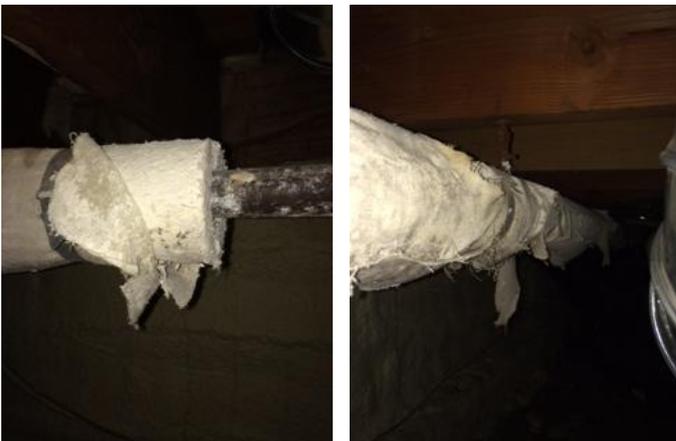
Location: Old heating system piping in the crawlspace

There is what appears to be friable asbestos insulation. I recommend further evaluation and mitigation as necessary by a qualified / licensed contractor.

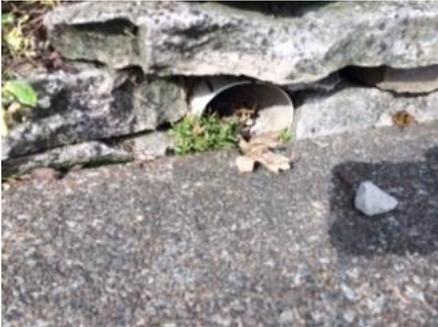
I would suggest the outlet ends of the underground extensions be screened to prevent debris or pest blockage. Regular cleaning is recommended.

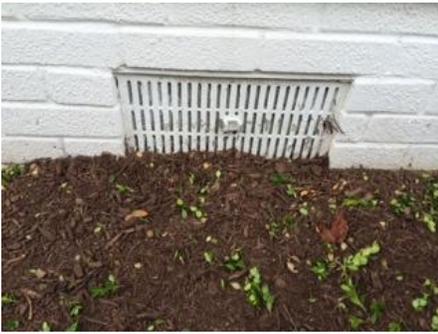
The vents are not all operable (able to open / close). Cleaning and/or lubrication are recommended. Some vents are slightly below grade. The bark ground cover should be cleared to prevent blockage.

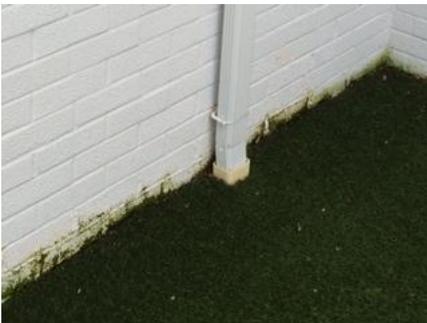
Location: NW

Poor pitch of the patio and/or improper function of the downspout extension appear to be preventing proper drainage of the patio. In addition, the bark ground cover is higher than the patio and is acting as a dam. Correction is recommended.

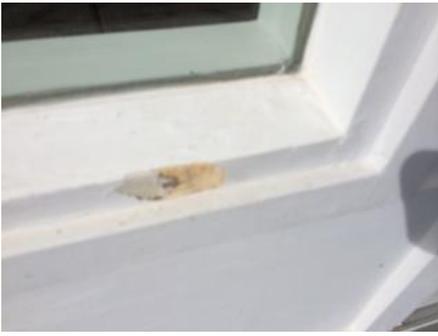
Location: Window sill at the west wall of the sunroom

There is some rot that has been filled and peeling paint.

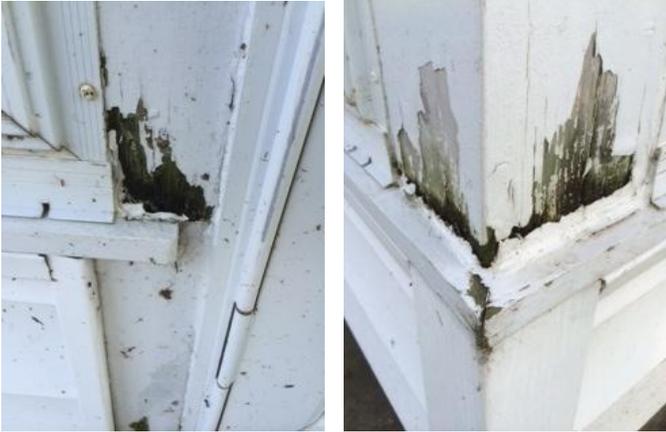
Location: Cottage window trim  
The trim is rotting. Repair or replacement is recommended.

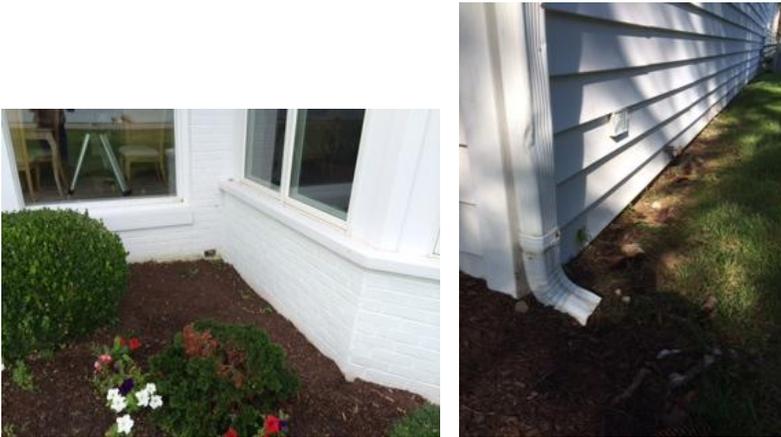
Locations include, but may not be limited to: NW inside corner of the house, cottage  
The negative grade should be corrected. Site drainage and roof runoff management should be optimized.

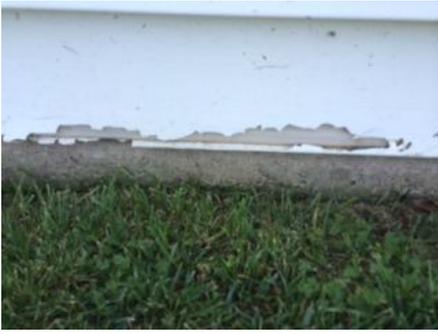
Location: Cottage  
The bottom course of siding is damaged in numerous locations.

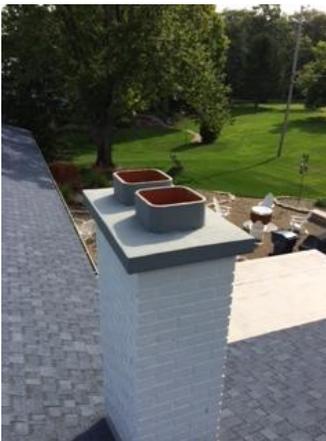
Location: West and East chimneys

Although some flues are inactive, the installation of rain caps is recommended.

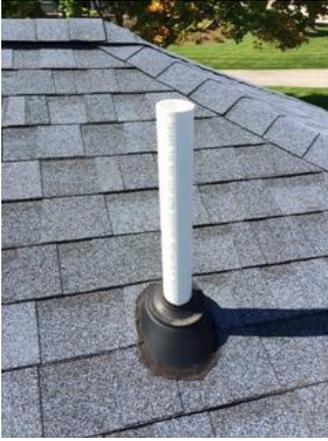
Location: Water heater exhaust vent

I would recommend that the top of the vent be elbowed over to prevent water penetration down the vent.

NOTE: Vent has the appearance of a DWV vent, but is the exhaust vent for the on demand water heater and is located on the east slope of the garage roof.

I would recommend that the top of the vent be elbowed over to prevent water penetration down the vent. See picture in the summary section.

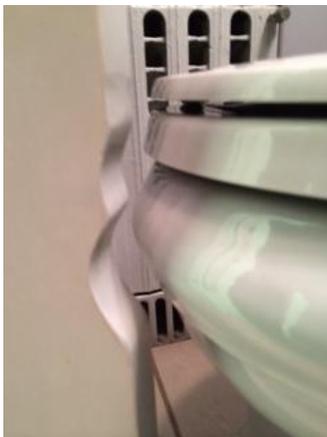
Location: Office bathroom

The door has been notched to clear the commode.

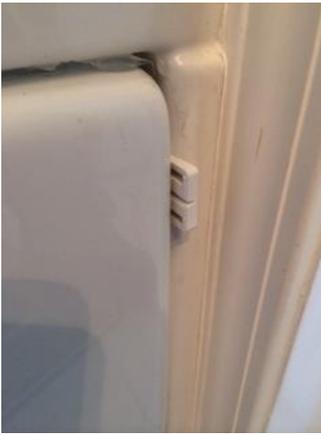
The access panel is shimmed to hold it in place.
